Círculo de Bellas Artes

Culture — Cultural centres

The accessibility of this tourism resource has been analyzed by experts

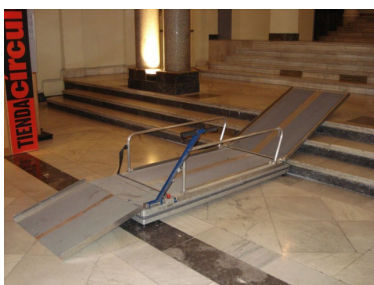
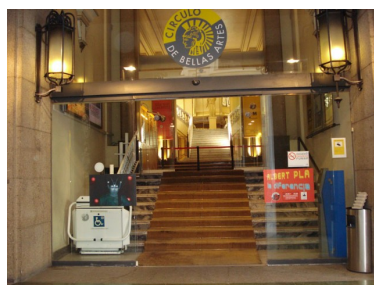
Entrance

Entrance: Lifting platform

The entranceway analysed is: The main one

Width of the entrance door: Greater than or equal to 78 cm

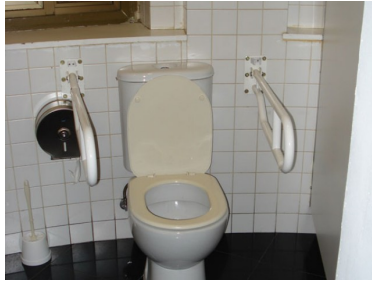
Adapted toilet in common areas

Access without changes in floor level: Yes

Door width: Greater than or equal to 78 cm

Door opening: Outward

Free turning space ? 150 cm of diameter: No

Clear space to transfer to the toilet: Yes

The space is at least 80 cm or greater: Right-hand side

Height of the toilet seat: Standard (between 40 and 45 cm)

It has support bar(s): Yes

Toilet grab bars: Left-hand side, right-hand side

The bars on the left-hand side are: Folding

The bars on the right-hand side are: Folding

Sink: Tap difficult to use

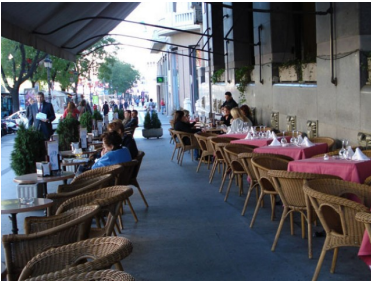
Outside areas

Sidewalks: Without obstacles

Uniform and anti-slip pavement: Yes
